# Wedgewire Screen Pilot Project

Final Report

December 7, 2020 – February 9, 2022

Prepared for Poseidon Resources (Channelside), LP

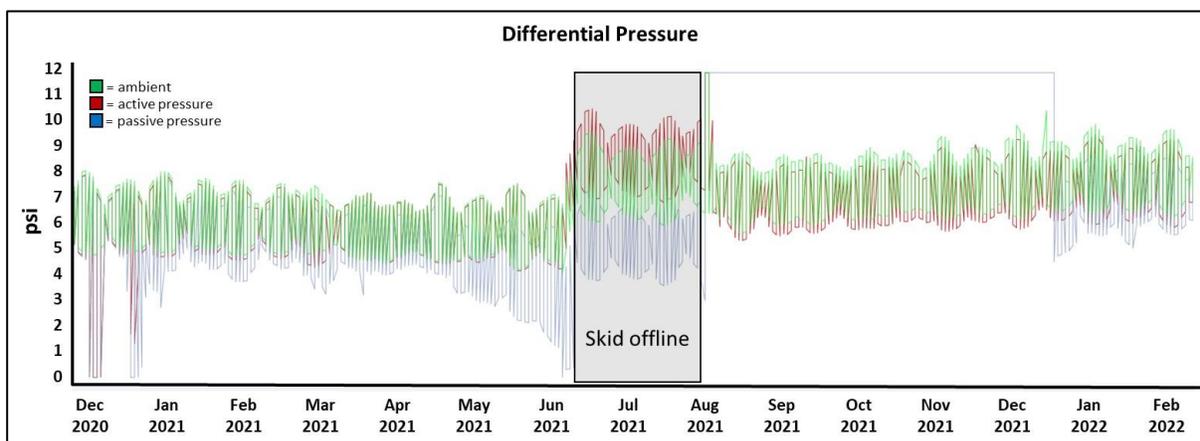
**Figure 13. Unplanned offline period (associated with the skid becoming partially un-anchored) based on differential pressure. Note the passive WWS decrease in pressure (i.e., increase in differential pressure) between mid-April and mid-June 2021. At the time the skid becomes partially un-anchored (gray box), the active and passive pressure transducers shift depth as well – captured as the change in pressures (relative to ambient) during the offline period.**

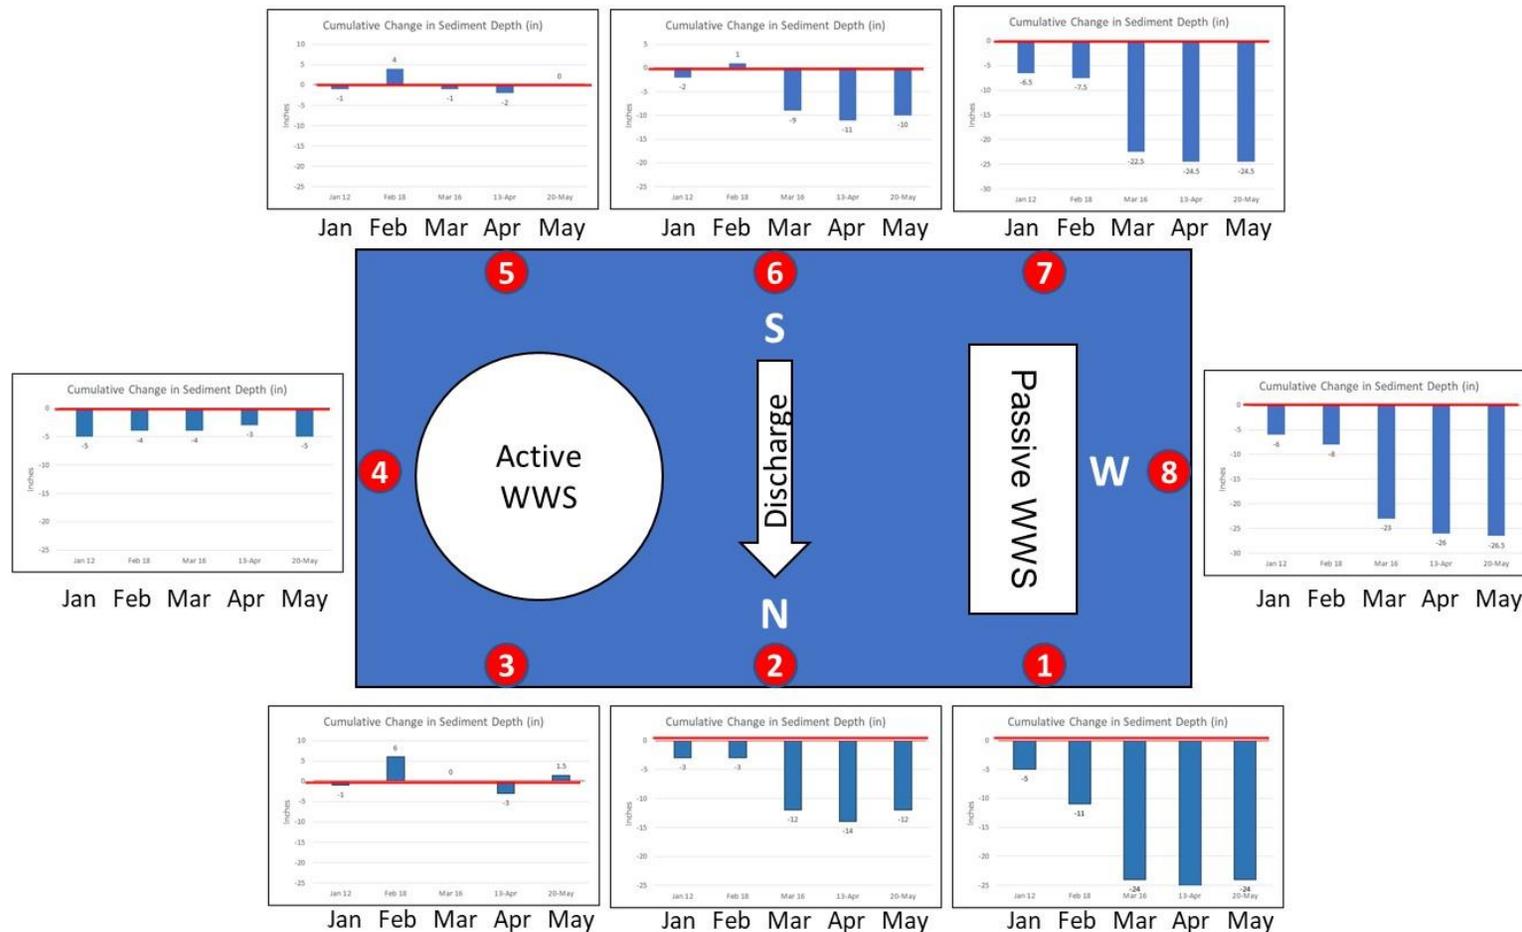
Sedimentation and scour data from Q1 and Q2 were valuable in documenting the partial un-anchoring of the skid during Q2 when scour appeared to be increasing each month (Figure 14). However, inspection of the passive WWS after the skid became partially un-anchored on June 14 revealed heavy internal biofouling that likely prevented the airburst air from escaping the screen. The lift created by trapped air inside the passive WWS likely caused helical anchors to pull out of the Lagoon floor. Skid levelness measurements support this conclusion with data indicating a slope downward to the east which would have resulted from the west side slowly lifting (Table 4).

**Figure 14. Cumulative depth (inches) change by month through May 20 dive survey (Q1 and most of Q2). Change is relative to the red lines in the charts which indicate the starting depth of sediment (Dec 9, 2020): above the red line was assumed to be sedimentation; below the red line was assumed to be scour.**

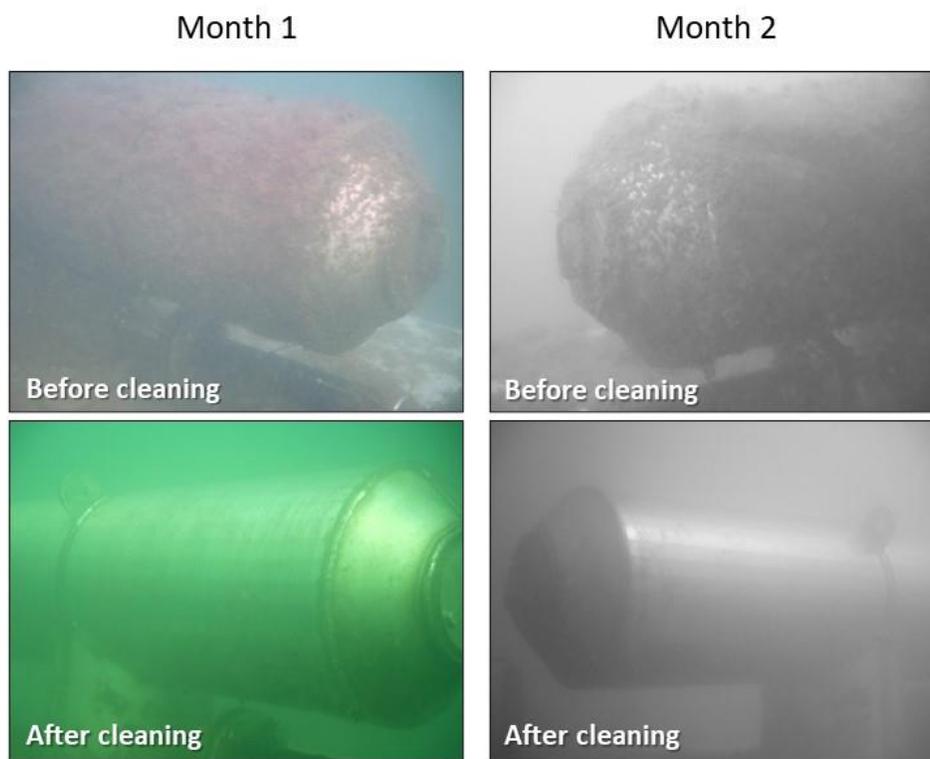
During the second month of operation, the passive WWS cleaning frequency was increased to four airbursts per day which appeared to improve performance (more gradual increase in DP) (Figure 15). Divers noted at the end of the second month that the passive WWS condition was the same – biofouled on 100% of the external screening surface with soft growth that was loosely attached (Figure 17). No hard macrofouling organisms were present on the exterior of the WWS. Removing the biofouling required very little effort; essentially a gloved hand was sufficient to sweep all external fouling off of the screen face. Divers also used a wire brush to ensure that the gaps between wires were cleared of any occlusions.

**Figure 17. Photos of the passive WWS before and after external cleaning by divers during months 1 (January 2021 dive survey) and 2 (February 2021 dive survey) of Q1. Note that no photos are available from Month 3 due to poor visibility.**

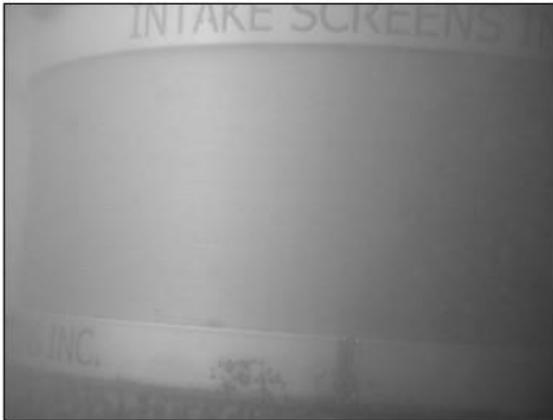
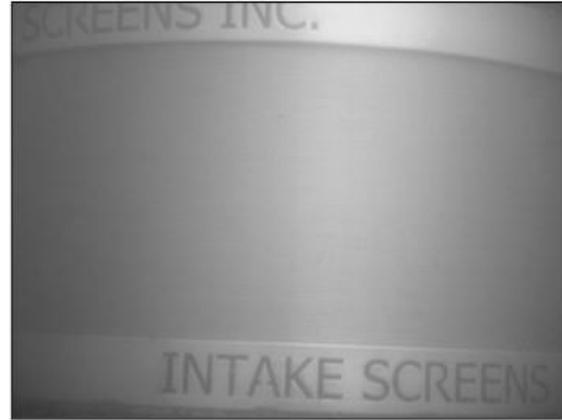
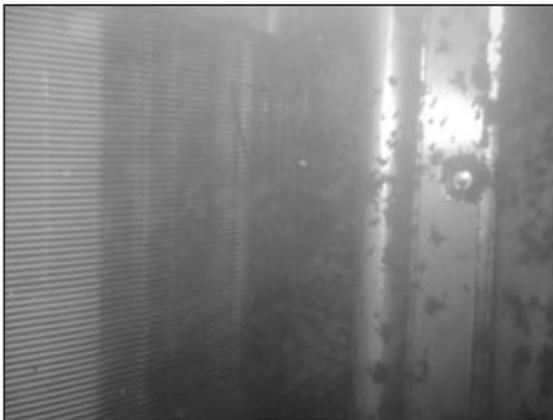
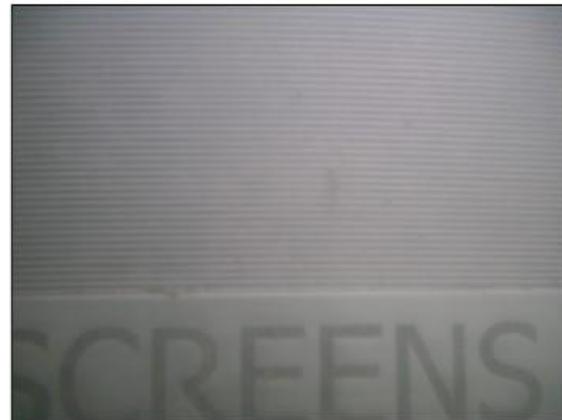
During the second month, the active WWS continued operating reliably at a cleaning frequency of three times per day with no measurable change in DP. Divers indicated that the active screen was still in excellent condition with no biofouling on the screening surface.

**Figure 20. Photos of the active WWS during months 1 (January 2021 dive survey) and 2 (February 2021 dive survey) of Q1. Note that no photos are available from Month 3 due to poor visibility.**

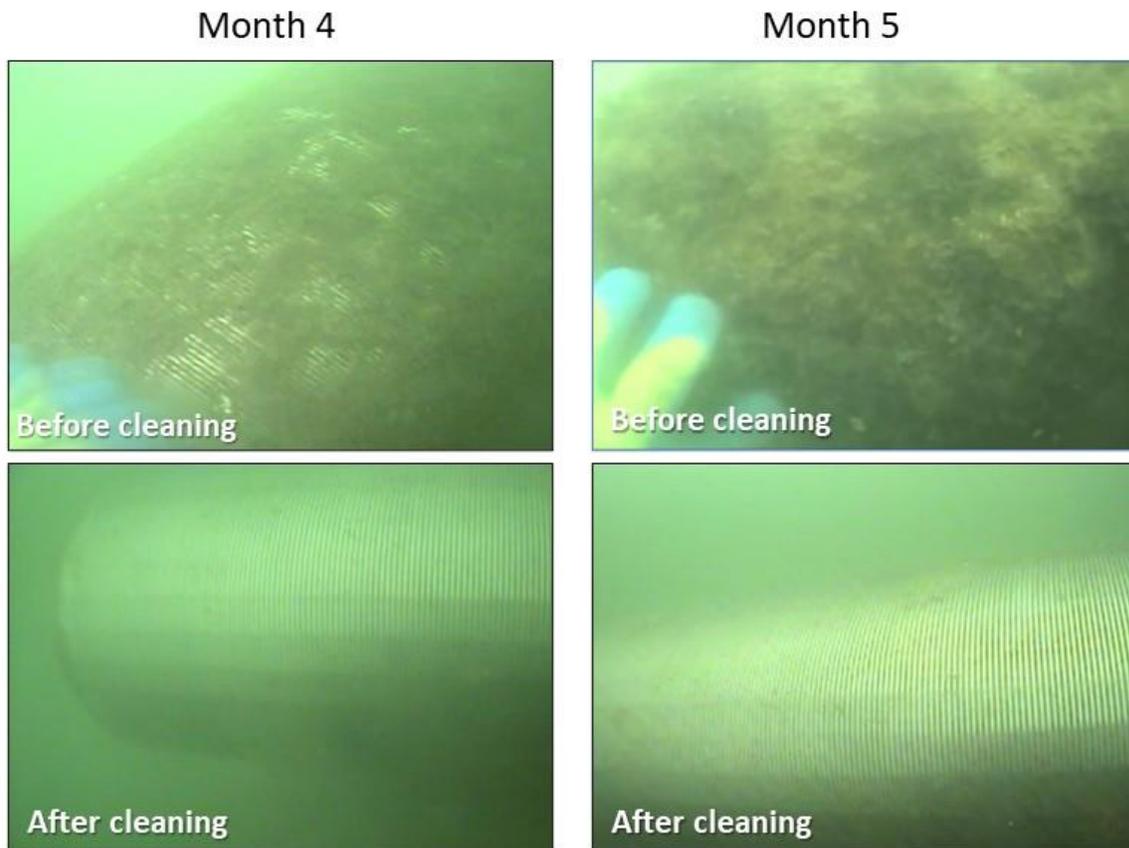
During the fifth month of operation, airburst continued to function at 4 times/day, The passive pump was returned to service (May 3) and DP began between 1.2 and 1.5 psi – no change from where it was before the manual cleaning by the divers. DP increased from approximately 1.5 to over 2 psi during that month (Figure 21) and divers noted between 80 and 100% biofouling coverage on the passive WWS external surface (Figure 22). No hard macrofouling organisms were present on the exterior of the WWS. Removing the biofouling required very little effort; essentially a gloved hand was sufficient to sweep all external fouling off of the screen face. Divers also used a wire brush to ensure that the gaps between wires were cleared of any occlusions.

Figure 22. Photos of the passive WWS before and after external cleaning by divers during months 4 (April 2021 dive survey) and 5 (May 2021 dive survey) of Q2.

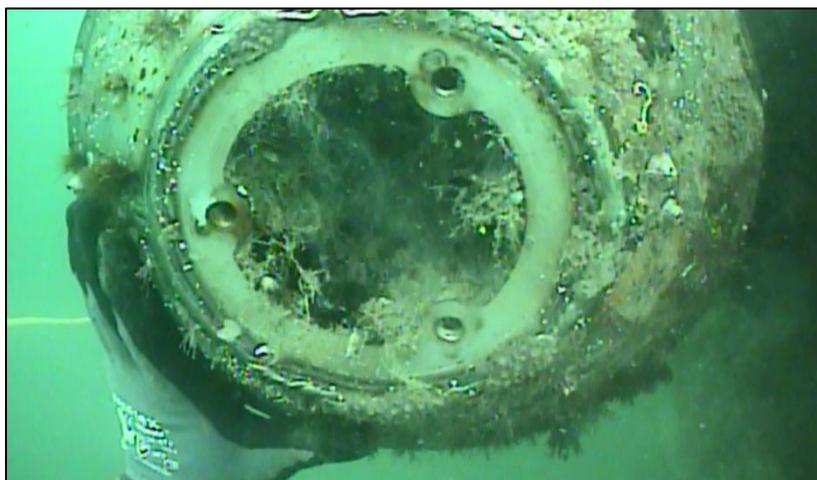
During the sixth month of operation, airburst continued to function at 4 times/day and the passive WWS experienced a sharp increase in DP, reaching over 3.5 psi. No hard macrofouling organisms were present on the exterior of the WWS. Removing the biofouling required very little effort; essentially a gloved hand was sufficient to sweep all external fouling off of the screen face. Divers also used a wire brush to ensure that the gaps between wires were cleared of any occlusions. Given the clean condition of the external passive WWS surface, this high DP is indicative of internal biofouling. Heavy internal fouling was confirmed at the end of the sixth month when divers had to inspect the skid after it became partially un-anchored. Divers opened one endcap of the passive WWS and noted that it was essentially completely clogged with mussels and sediment (Figure 23). Under these conditions, airburst air would have difficulty escaping from the screen. See Appendix D for additional details on the June 18, 2021 dive survey during which inspection of the partially un-anchored skid was completed.

Figure 23. Photo of biofouling inside of passive WWS after month 6 of operation (June 2021 dive survey) – endcap removed.

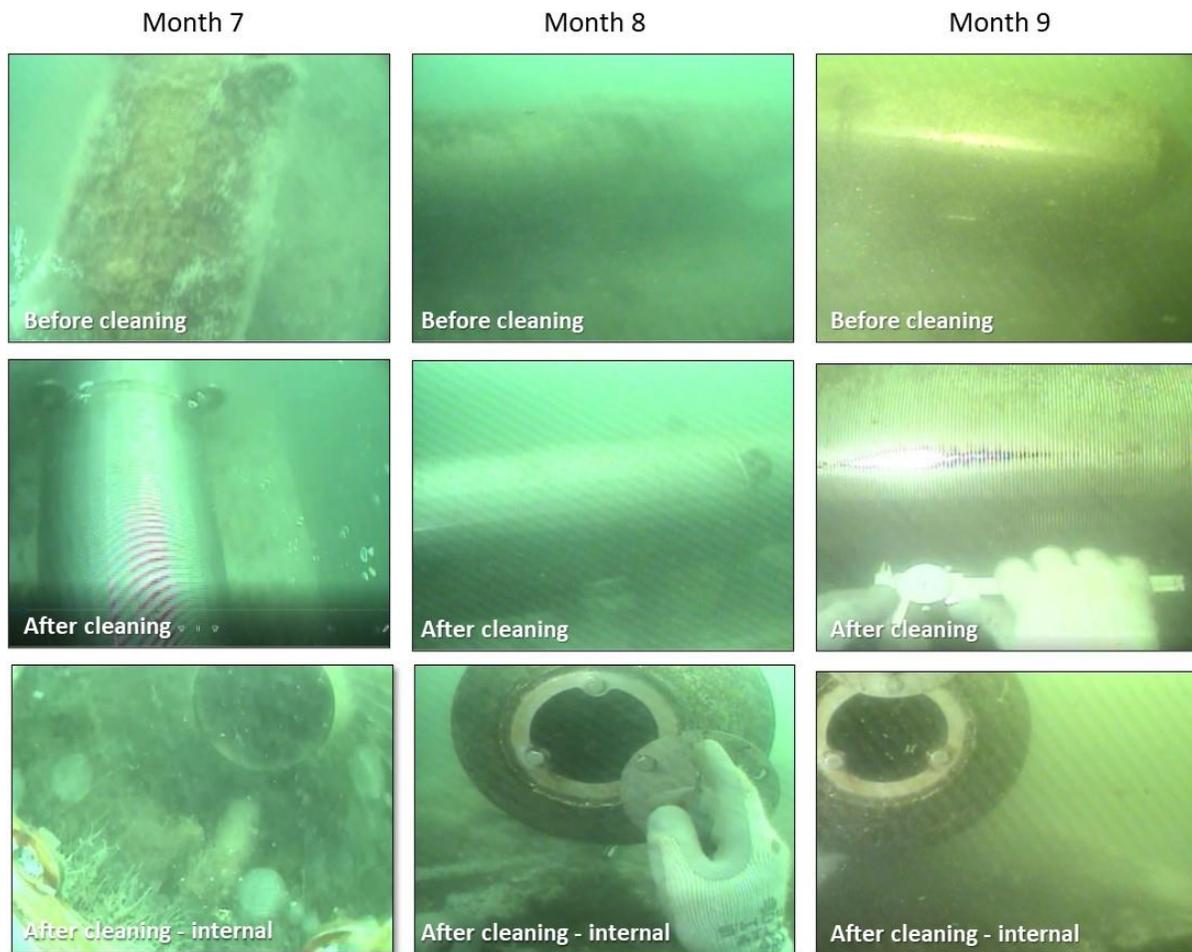
In Q3, an approximately one-inch thick layer of soft growth had accumulated on 100% of the passive WWS external surface during the seventh and eighth months, though video observations indicate it was a bit less (60-70% coverage of up to ½-inch of soft growth) during the ninth month. No hard macrofouling organisms were present on the external surfaces. Biofouling was removed with a pressure washer and, where required, divers also used a wire brush to ensure that the gaps between wires were cleared of any occlusions. Inspection of the internal surfaces showed a light layer of soft growth and minimal hard growth (small mussels) for all three monthly dive surveys during Q3. Divers noted that during the November survey, there was approximately 50% coverage of hard growth on the inside surface the passive and active pump boxes.

**Figure 26. Photos of the passive WWS before and after external and internal cleaning by divers during months 7 (September 2021 dive survey), 8 (October 2021 dive survey), and 9 (November 2021 dive survey) of Q3.**

The cleaning frequency for the passive WWS was increased from four airbursts per day to eight in an effort to prevent the settlement of any hard macrofoulers on the interior of the screen. The passive WWS was cleaned in place both internally and externally each month throughout Q3 using a pressure washer and a wire brush. This updated cleaning regime proved to be sufficient for maintaining the passive WWS in good condition. Due to the failure of the passive pressure transducer on August 8, 2021 (replacement transducer not available until December 15, 2021) and the passive flowmeter, no quantitative data were available for the passive WWS during Q3; therefore, data collection was limited to the monthly dive observations conducted (Figure 26).

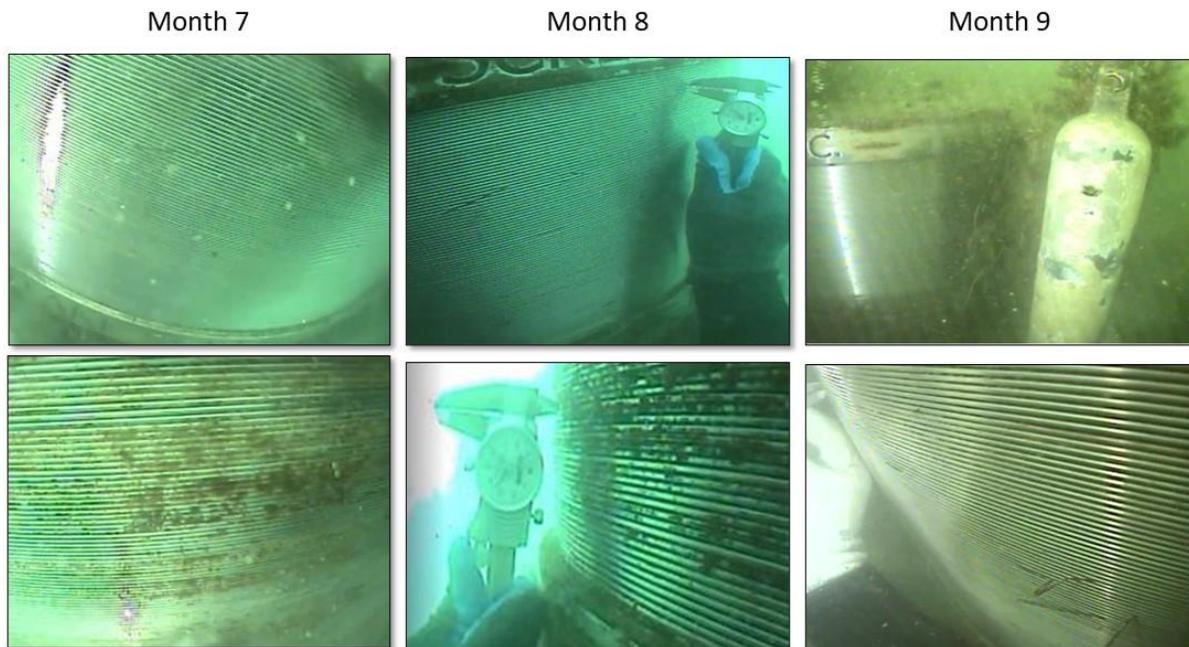
WWS; additionally, the debris is likely released from the brush when the WWS rotates in the opposite direction during a cleaning cycle. No hard macrofouling organisms were present on the external surfaces during any of the Q3 diver surveys. Divers adjusted the brush to make full contact with the screen. Divers noted that during the November survey, there was approximately 50% coverage of hard growth on the inside surface of the active and passive pump boxes.

**Figure 29. Photos of the active WWS during months 7 (September 2021 dive survey), 8 (October 2021 dive survey), and 9 (November 2021 dive survey) of Q3**

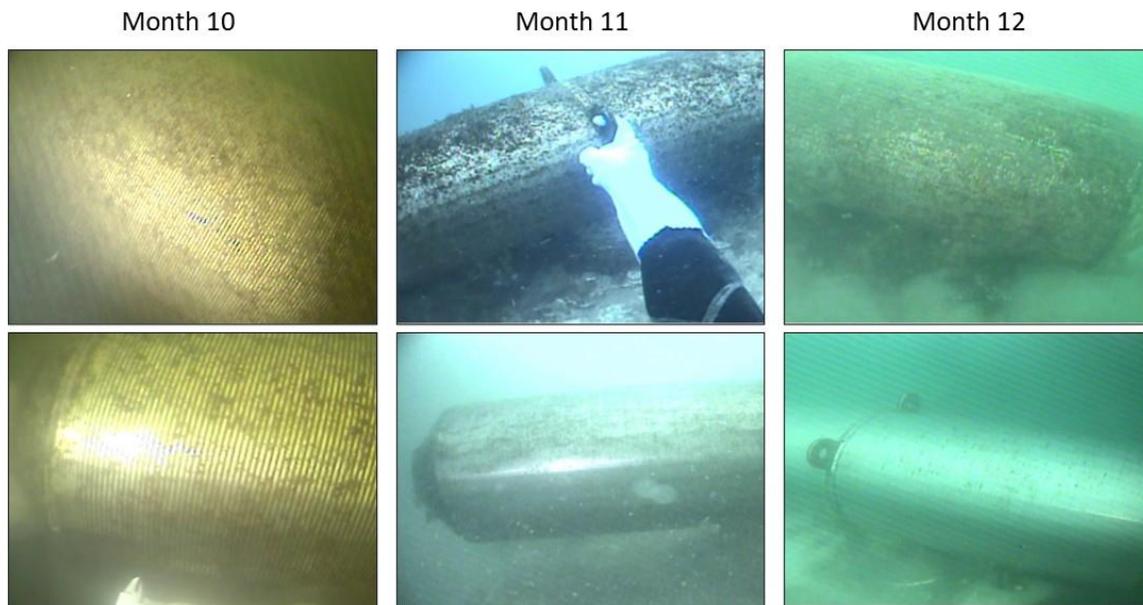
**Figure 31. Photos of the passive WWS before and after external and internal cleaning by divers during months 10 (December 2021 dive survey), 11 (January 2022 dive survey), and 12 (February 2022 dive survey) of Q4.**

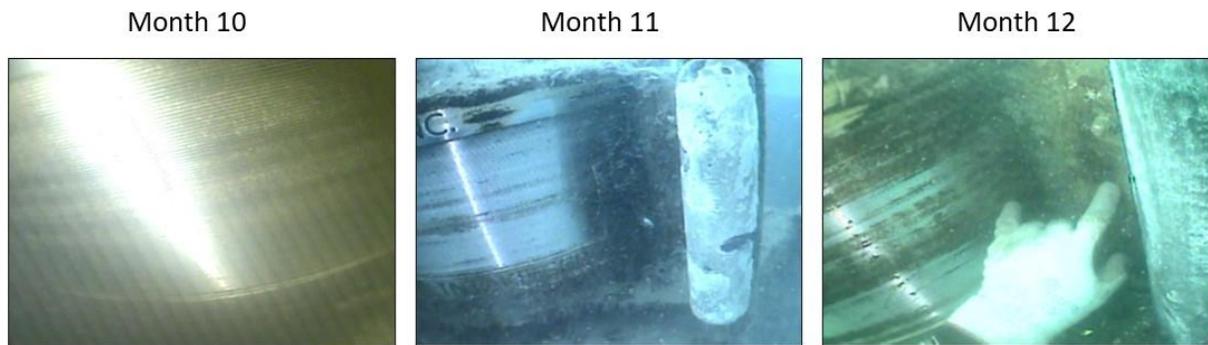
During Q4, divers noted that the active WWS remained clean, with little biofouling. The external surface of the active WWS still had some streaks of soft growth (Figure 33). Although the divers adjusted the brush during month 10, some streaking remained, indicating that the brush may require more frequent inspection for proper engagement. Regardless, the active WWS operated reliably maintained low DP. No hard macrofouling organisms were present on the external surfaces during any of the Q4 diver surveys.

Figure 33. Photos of the active WWS divers during months 10 (December 2021 dive survey), 11 (January 2022 dive survey), and 12 (February 2022 dive survey) of Q4.

- A new anode bracket was installed on November 18 to provide cathodic protection to the new active flowmeter.
- The passive pressure transducer was replaced on December 15, 2021.
- The external brush on the active WWS was adjusted to be in closer contact with the screening surface on December 15, 2021.

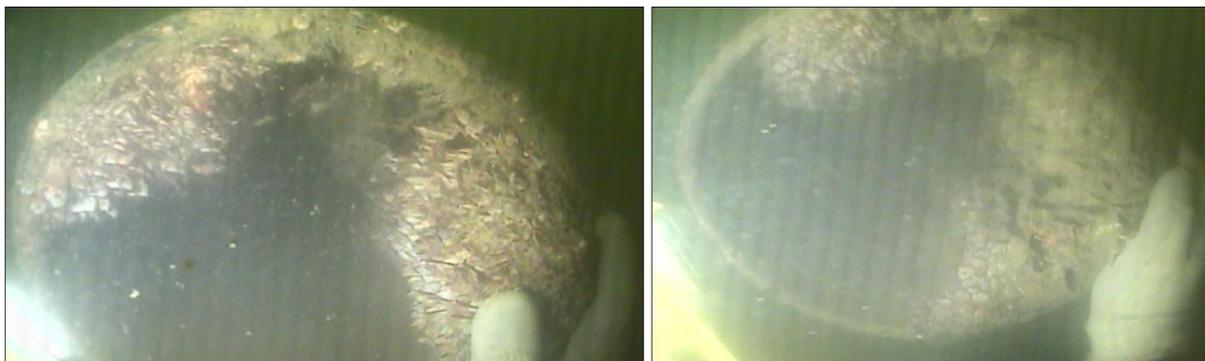
Figure 34. Heavy macrofouling growth in the discharge diffuser piping (diameter of 12 inches).

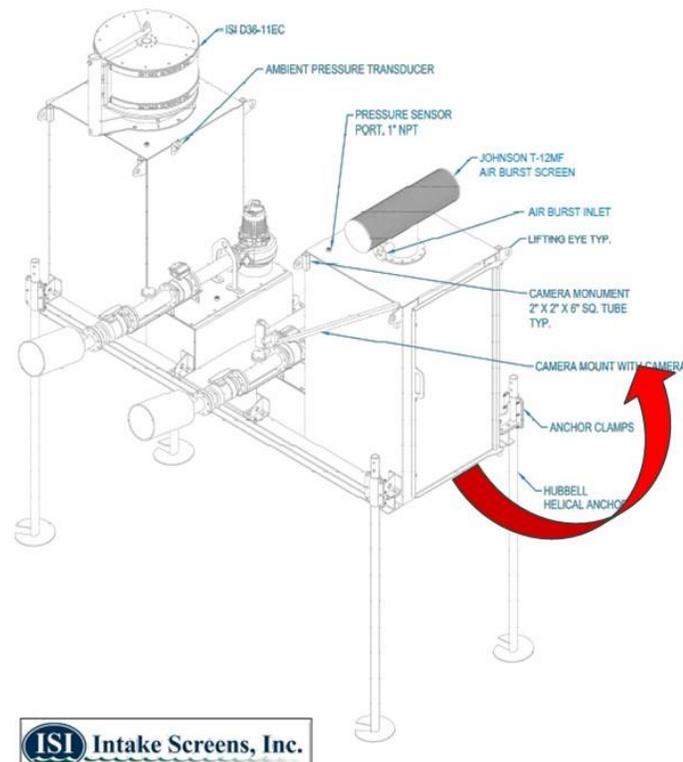
- At some point during Q2, the active flowmeter developed a 1/16-inch corrosion hole in the body of the meter. Flow rate data appeared unaffected.
- The skid became partially un-anchored from the Lagoon floor and tipped with its passive side moving up toward the surface and the active side moving down toward the Lagoon floor. DP data indicate that it happened on June 14, 2021. Since the dive survey was not conducted until June 18, 2021, the skid was in operation for approximately four days while partially un-anchored. Out of an abundance of caution, the skid components were LOTO'd until divers and surface support personnel righted, repaired, and re-anchored the skid during a four-day period between August 9 to 12, 2021. All skid surfaces including both WWS were cleaned of all fouling prior to re-commissioning the Pilot Project system on August 12, 2021 (see Appendix D for additional detail on the skid tipping and re-anchoring effort). A post-re-anchoring baseline survey was conducted on August 13, 2021 as a starting point for subsequent monthly surveys. Analysis of the data and sequence of events leading to the skid becoming partially un-anchored indicate that during the approximately two and a half-week period during Q1 when the passive WWS was not airburst (PLC was programmed to trigger cleaning only when a low flow rate or high DP occurred; see Table 1), hard macrofouling organisms likely settled on the internal surfaces of the screen, particularly the internal flow distribution manifold. Due to approximately two and half weeks of no airbursting, the settled organisms had attached strongly enough to resist any dislodging forces created by the airburst and eventually grew to foul the majority of the internal surfaces. After experimenting with cleaning regimes and frequencies during the three phases of Q1, a timed sequence (i.e., a certain number of cleaning cycles per day) was identified as the best method to ensure stable operation. For a full-scale installation, a timed airburst frequency would be recommended at a minimum before considering additional cleaning strategies (i.e., triggering airburst cleaning based on flow rate or differential pressure).

**Figure D-1. Direction that skid tipped indicated with arrow. Passive (west) side floated to surface and active (east) side sank toward Lagoon floor.**

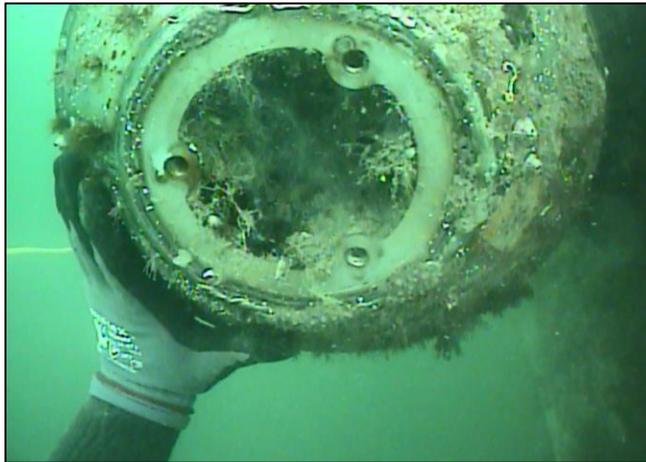
**Figure D-2. Diver photo of fouling inside of passive screen – endcap removed.**

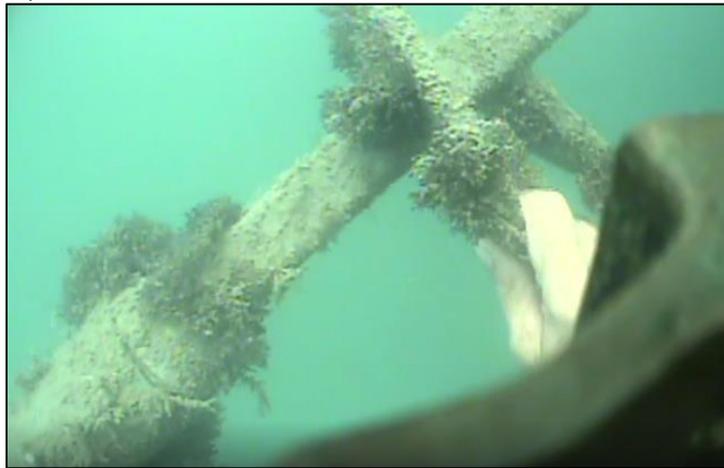
**Figure D-3. One of the two passive side helical anchors that had removed itself from the Lagoon floor during the skid tipping.**

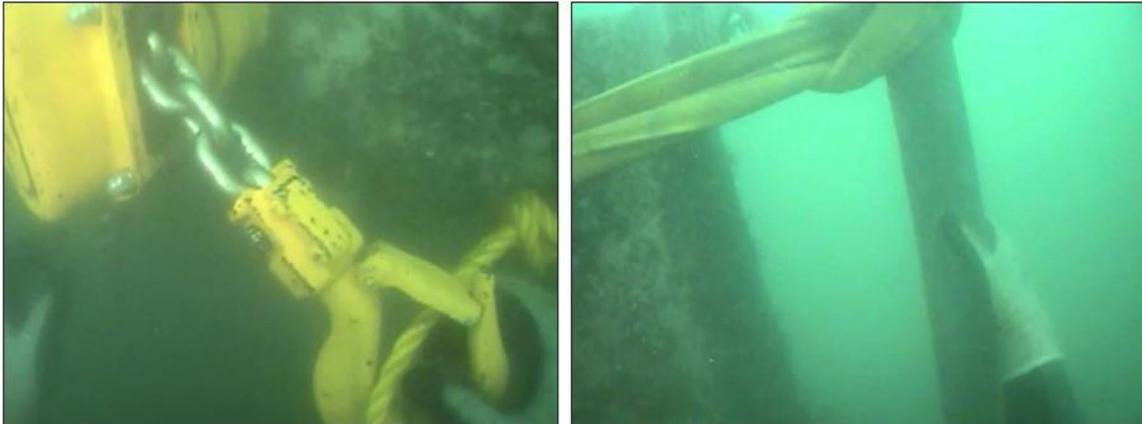
**Figure D-4. Bent anchor clamps on active side being straightened with come-along (left) and using helical anchor shaft for leverage (right)**

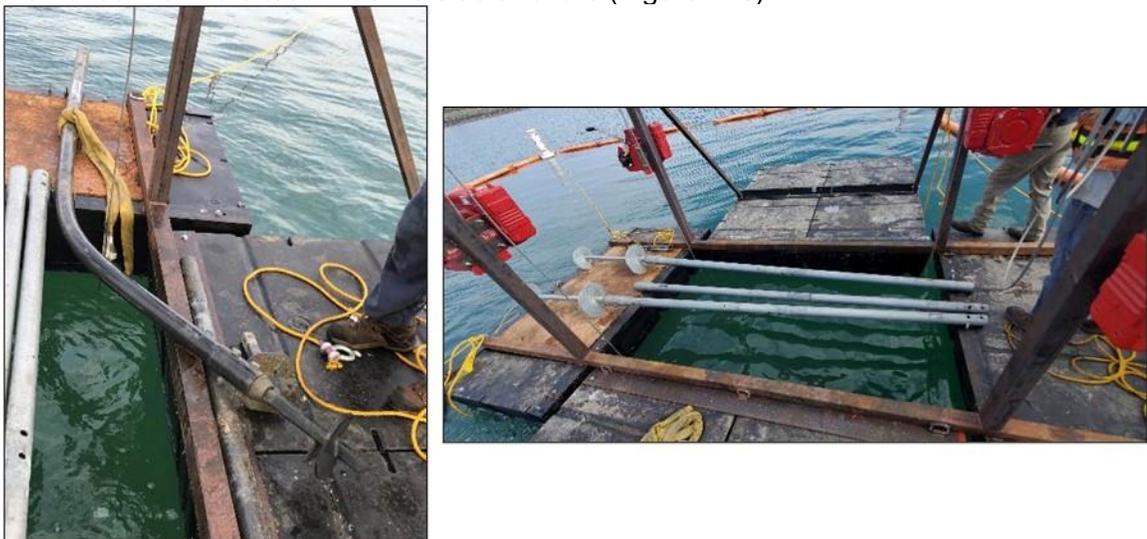
**Figure D-5. One of the two bent active side helical anchors removed (left) and two of the four new helical anchors installed.**

- Removed the two old/bent active side anchors (Figure D-5)

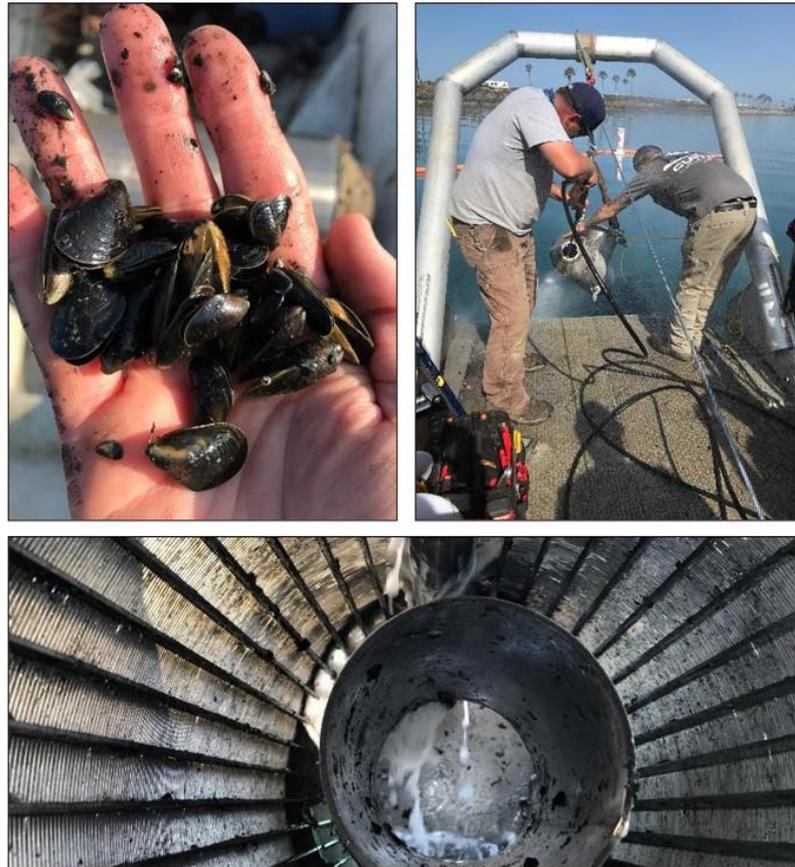
**Figure D-6. Blue mussels removed from inside passive screen (top left), divers cleaning passive screen with pressure washer after it had been recovered to the surface (top right), and view through endcap of cleaned internal surfaces.**

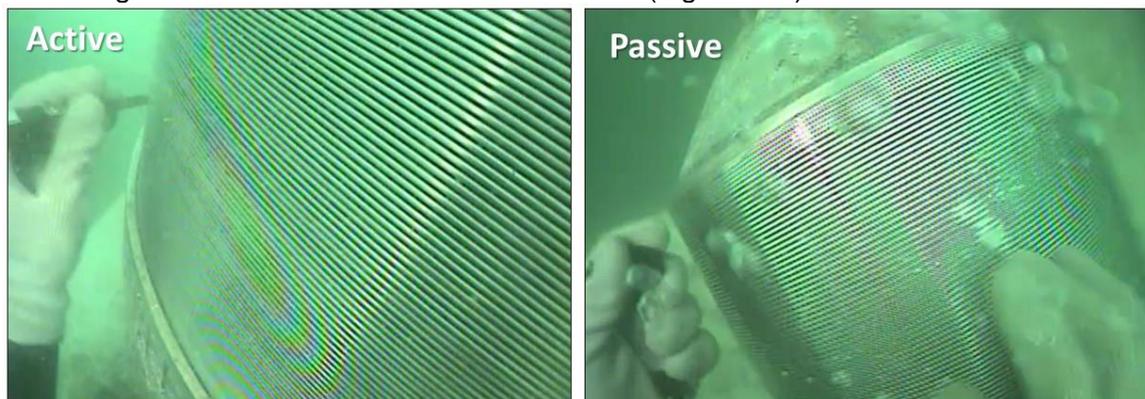
**Figure D-7. Like-new condition of external screening surfaces of active screen (left) and passive screen (right).**
