# Wedgewire Screen Pilot Project

Final Report

December 7, 2020 – February 9, 2022

Prepared for Poseidon Resources (Channelside), LP

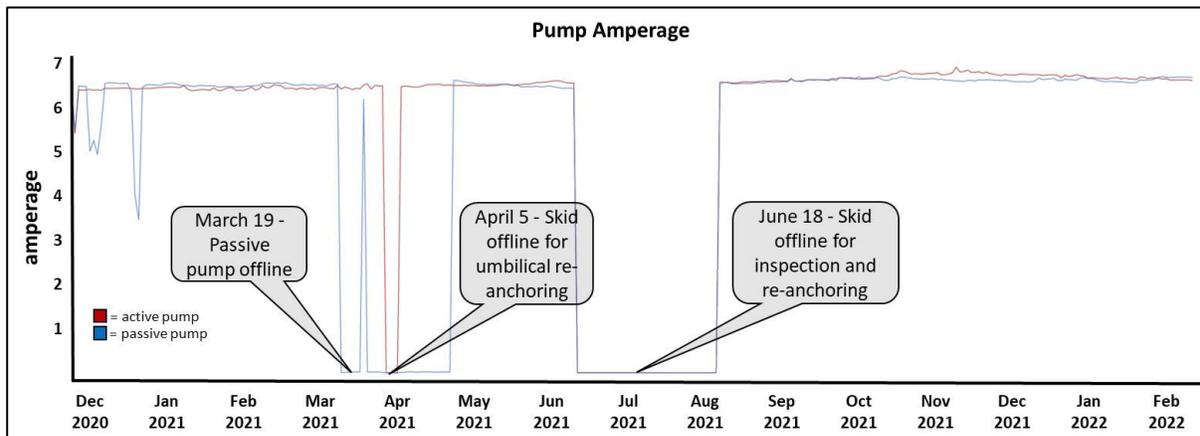
During the 12 months of operation, the submersible pumps were set at approximately 600 gpm and the screen cleaning mechanisms were set as described in Table 1. The system was taken offline weekly for planned maintenance (15 to 20-minute per week) so that the turbidity sample lines could be backflushed. The system was also taken offline monthly to conduct the planned dive surveys (six to eight-hours per month) during which all skid components were LOTO for diver safety. Additional unplanned offline periods for maintenance are described in Chapter 4 (e.g., anode replacement, umbilical anchoring, skid tipping, flowmeter replacement); the major unplanned offline periods are shown in Figure 12 and Figure 13.

**Figure 12. Principal unplanned offline periods for the wedgewire Pilot Project based on pump amperage (on/off).**

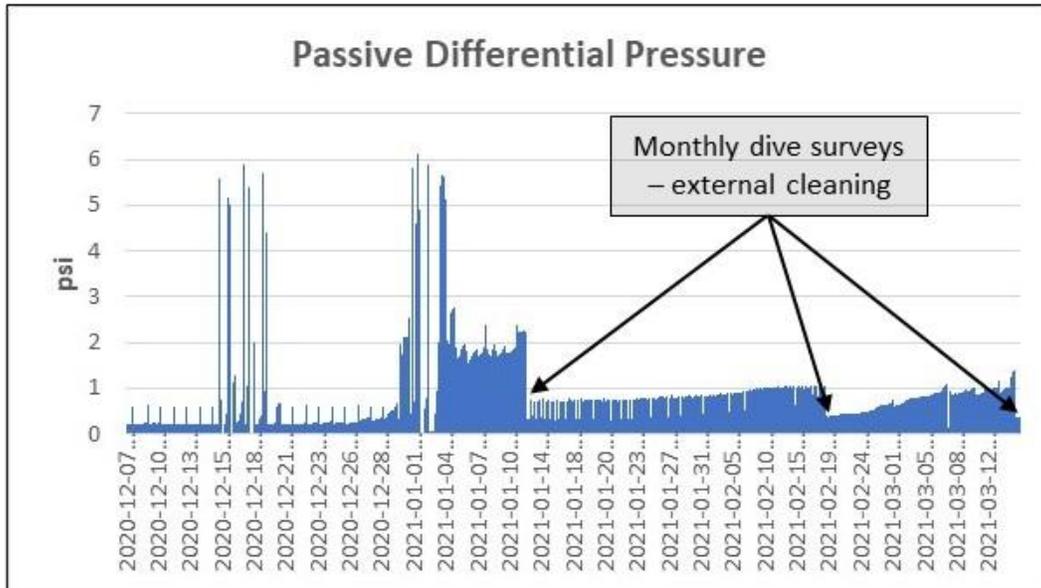
During the first month of operation, passive DP increased over time (Figure 15) indicating the presence of biofouling accumulation in the passive WWS assembly that was not mitigated by the airburst system operating at one airburst per day. In addition, there were a few incidents of increased DP which may indicate that a clogging event (free-floating debris, not biofouling) was taking place. Figure 16 illustrates how DP recovered in the passive WWS after a suspected clogging event during Q1. Though the passive WWS recovered, the recovery did not last long at the airburst frequency of once per day. During the dive survey at the end of the first month, divers indicated that the biofouling that had accumulated on 100% of the passive WWS external surface (Figure 17), though the material was soft and loosely attached. No hard macrofouling organisms were present on the exterior of the WWS. Removing the biofouling required very little effort; essentially a gloved hand was sufficient to sweep all external fouling off of the screen face. Divers also used a wire brush to ensure that the gaps between wires were cleared of any occlusions.

During the second month of operation, the passive WWS cleaning frequency was increased to four airbursts per day which appeared to improve performance (more gradual increase in DP) (Figure 15). Divers noted at the end of the second month that the passive WWS condition was the same – biofouled on 100% of the external screening surface with soft growth that was loosely attached (Figure 17). No hard macrofouling organisms were present on the exterior of the WWS. Removing the biofouling required very little effort; essentially a gloved hand was sufficient to sweep all external fouling off of the screen face. Divers also used a wire brush to ensure that the gaps between wires were cleared of any occlusions.

During the third month of operation, the passive WWS cleaning was programmed to initiate airbursts based on low flow rate or high DP (Table 1). This cleaning regime resulted in faster increase in DP, since none of the threshold triggers were reached to initiate an airburst for approximately two and half weeks. This allowed biofouling to accumulate unimpeded on the external screening surface. Biofouling also became established on the internal screening surface as would be evidenced in subsequent observations. Divers noted no difference in the external appearance of the passive WWS – biofouled on 100% of the external screening surface with soft growth that was loosely attached. No hard macrofouling organisms were present on the exterior of the WWS. Removing the biofouling required very little effort; essentially a gloved hand was sufficient to sweep all external fouling off of the screen face. Divers also used a wire brush to ensure that the gaps between wires were cleared of any occlusions.

Figure 15. Differential pressure through passive wedgewire screening assembly during Q1.

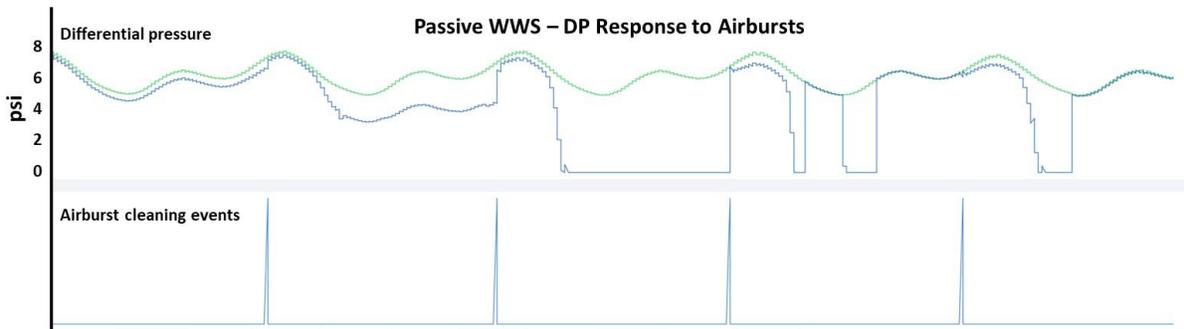
Figure 16. Effectiveness of cleaning method for controlling DP in pilot-scale passive wedgewire intake screening assembly. Data show a four-day period (December 29, 2020 – January 2, 2021) during which a suspected clogging event occurred.

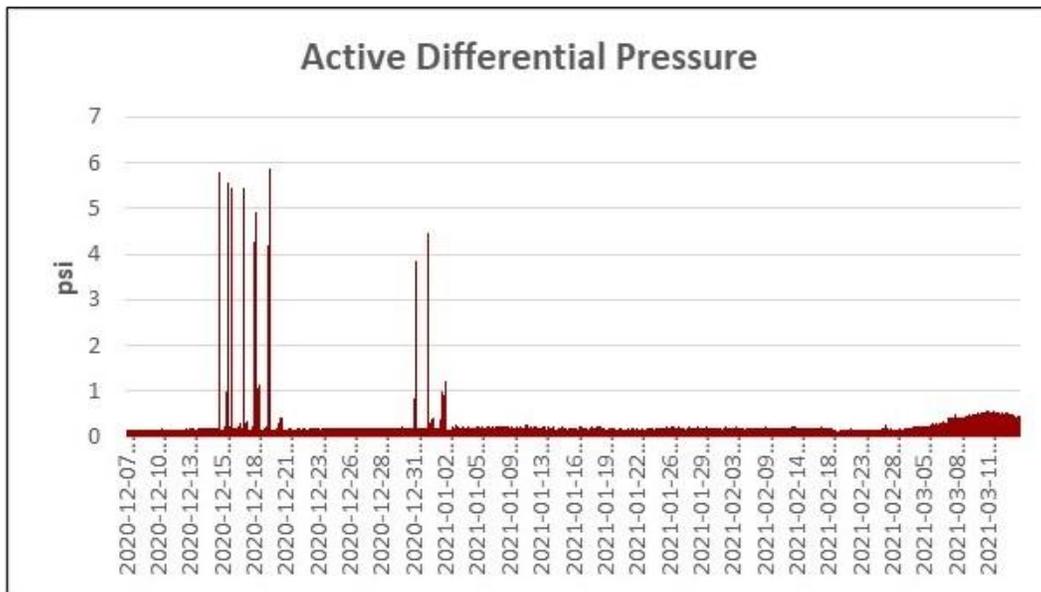
During the first month, the active WWS maintained stable operation at a cleaning frequency of three times per day. DP remained low except for a few incidents of higher DP which may indicate that a clogging event (free-floating debris, not biofouling) was taking place and affecting both screens (Figure 18). Automated cleaning of the active WWS resulted in recovery of DP. Figure 19 illustrates how DP recovered in the active WWS after a suspected clogging event during Q1. The active WWS recovered quickly and was able to maintain low DP at a screen cleaning frequency of three times per day. Note that the active WWS has both external and internal brushes. Divers indicated that the active screen was in excellent condition with no biofouling on the screening surface.

During the third month, the active WWS did not initiate any cleaning cycles (since the cleaning regime was based on flow rate or DP, see Table 1) and, as a result, accumulated a

layer of biofouling on the external screening surface. Once the timed cleaning schedule was resumed in the third month, the active WWS reverted to a clean condition with DP dropping from approximately 0.4 psi to at the end of Q1 to approximately 0.02 psi at the beginning of Q2.

Figure 18. Differential pressure through active wedgewire screening assembly during Q1.

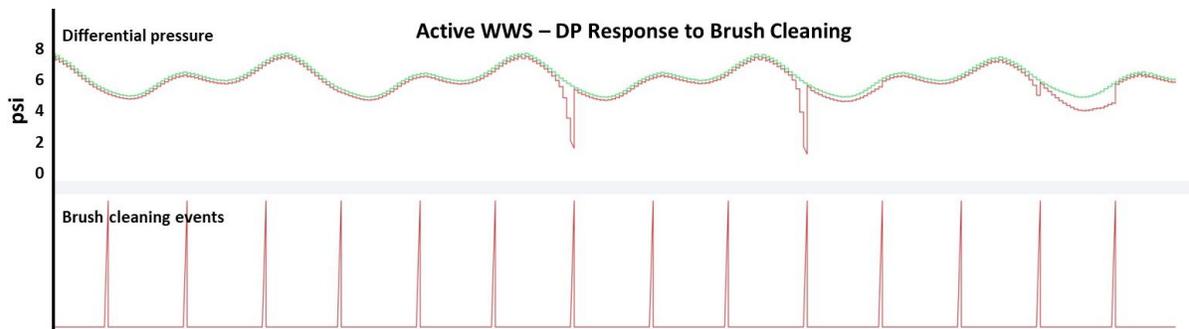
Figure 19. Effectiveness of cleaning method for controlling DP in pilot-scale active wedgewire intake screening assembly. Data show a four-day period (December 29, 2020 – January 2, 2021) during which a suspected clogging event occurred.

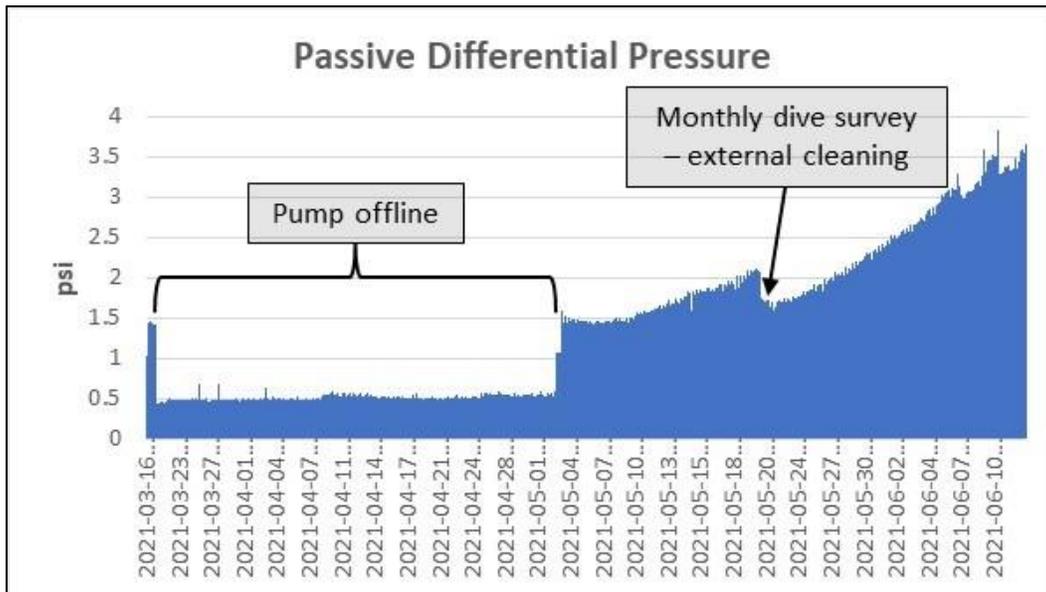
During the fifth month of operation, airburst continued to function at 4 times/day, The passive pump was returned to service (May 3) and DP began between 1.2 and 1.5 psi – no change from where it was before the manual cleaning by the divers. DP increased from approximately 1.5 to over 2 psi during that month (Figure 21) and divers noted between 80 and 100% biofouling coverage on the passive WWS external surface (Figure 22). No hard macrofouling organisms were present on the exterior of the WWS. Removing the biofouling required very little effort; essentially a gloved hand was sufficient to sweep all external fouling off of the screen face. Divers also used a wire brush to ensure that the gaps between wires were cleared of any occlusions.

During the sixth month of operation, airburst continued to function at 4 times/day and the passive WWS experienced a sharp increase in DP, reaching over 3.5 psi. No hard macrofouling organisms were present on the exterior of the WWS. Removing the biofouling required very little effort; essentially a gloved hand was sufficient to sweep all external fouling off of the screen face. Divers also used a wire brush to ensure that the gaps between wires were cleared of any occlusions. Given the clean condition of the external passive WWS surface, this high DP is indicative of internal biofouling. Heavy internal fouling was confirmed at the end of the sixth month when divers had to inspect the skid after it became partially un-anchored. Divers opened one endcap of the passive WWS and noted that it was essentially completely clogged with mussels and sediment (Figure 23). Under these conditions, airburst air would have difficulty escaping from the screen. See Appendix D for additional details on the June 18, 2021 dive survey during which inspection of the partially un-anchored skid was completed.

Figure 21. Differential pressure through passive wedgewire screening assembly during Q2.

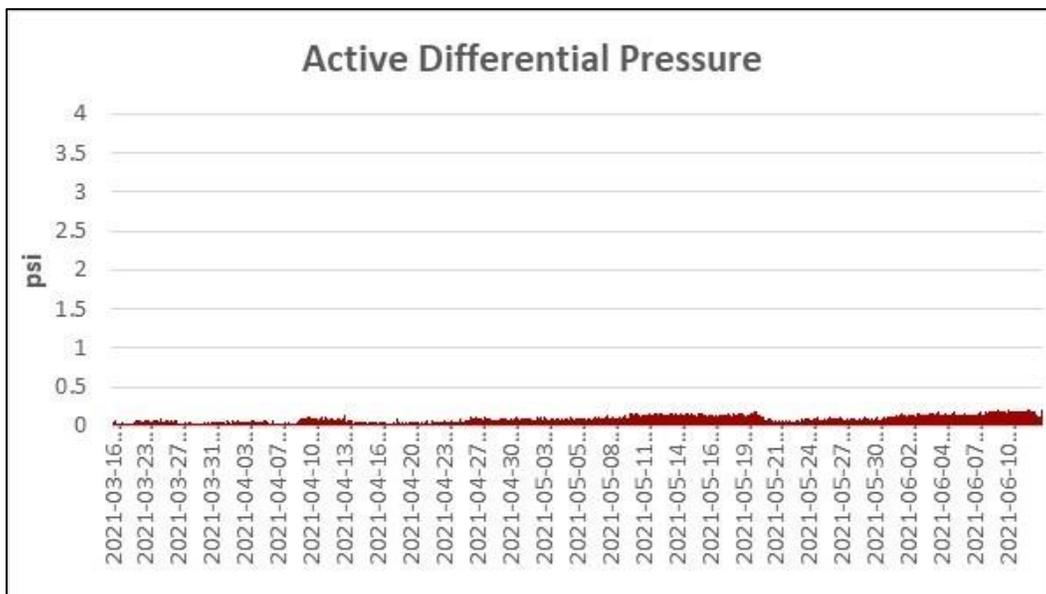
During months four and five of operation, the active WWS functioned reliably at a cleaning frequency of three times/day (no change from other operational periods in this study). DP never exceeded approximately 0.2 psi (Figure 24). Divers noted small streaks of soft growth on portions of the active WWS external surface (Figure 25). No hard macrofouling organisms were present on the exterior of the active WWS.

**Figure 24. Differential pressure through active wedgewire screening assembly during Q2. Note Y axis scale extends to 4 psi for comparison with the passive wedgewire screening assembly.**

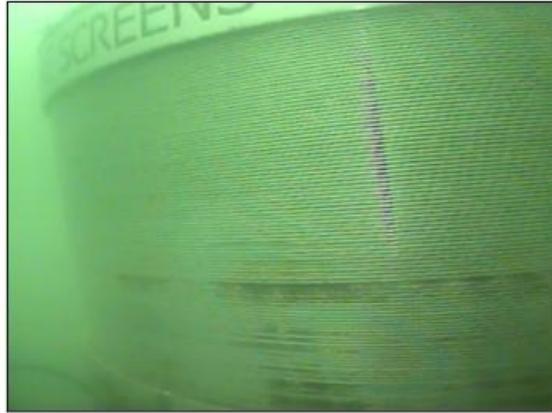
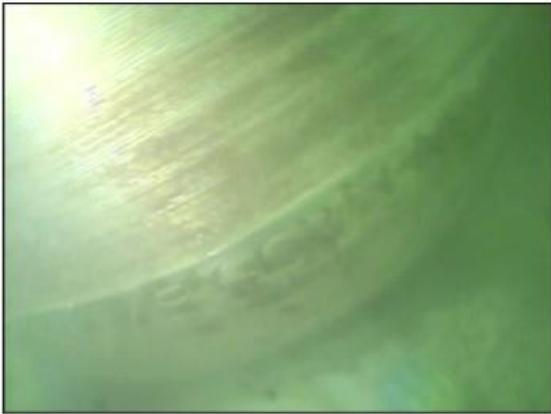
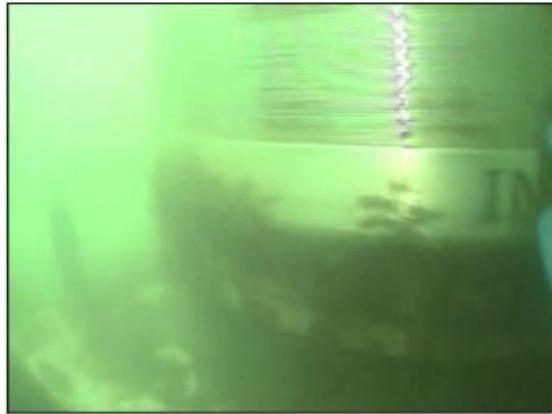
Figure 25. Photos of the passive WWS during months 4 (April 2021 dive survey) and 5 (May 2021 dive survey) of Q2.

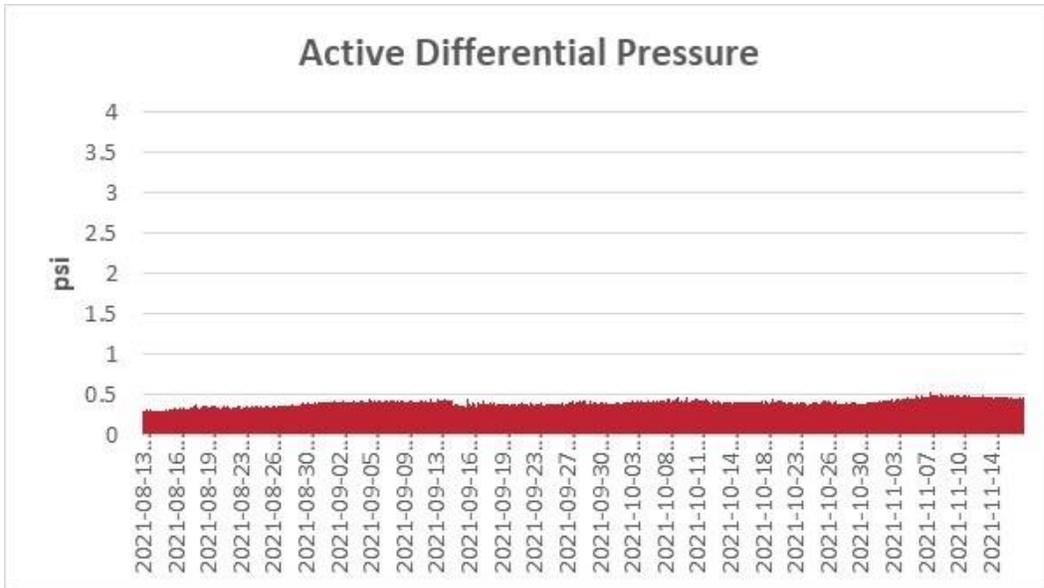
During Q3 of operation, the active WWS functioned reliably at a cleaning frequency of three times/day (no change from other operational periods in this study). DP remained below approximately 0.5 psi (Figure 27). Figure 28 presents the same DP data on a greatly reduced Y-axis scale to simply illustrate the DP trend.

**Figure 27. Differential pressure through active wedgewire screening assembly during Q3. Note Y axis scale extends to 4 psi.**

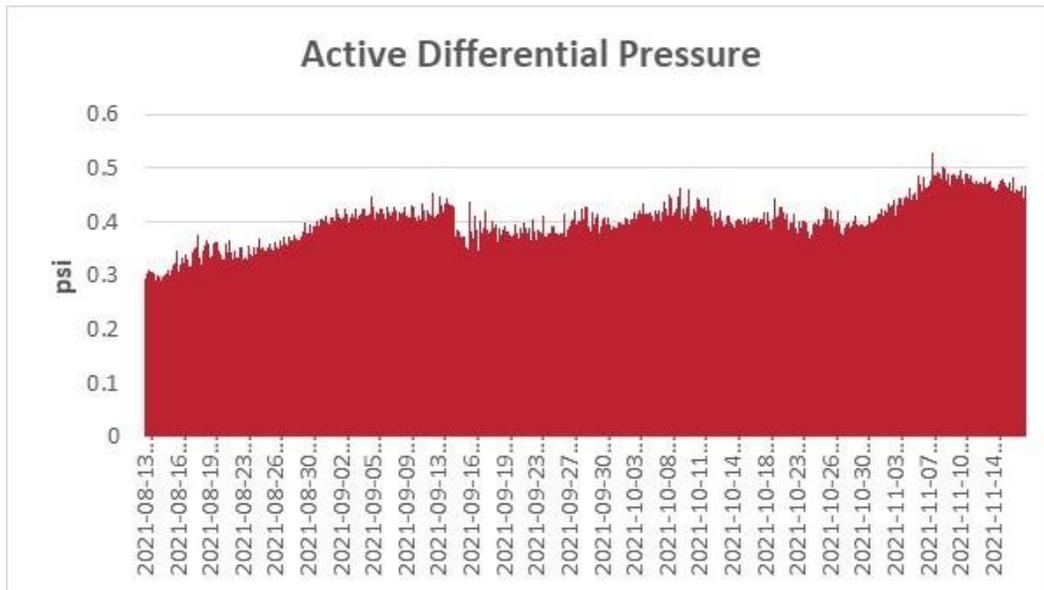
**Figure 28. Differential pressure through active wedgewire screening assembly during Q3. Note Y axis scale has been reduced substantially to illustrate a trend of increasing (albeit small) DP.**

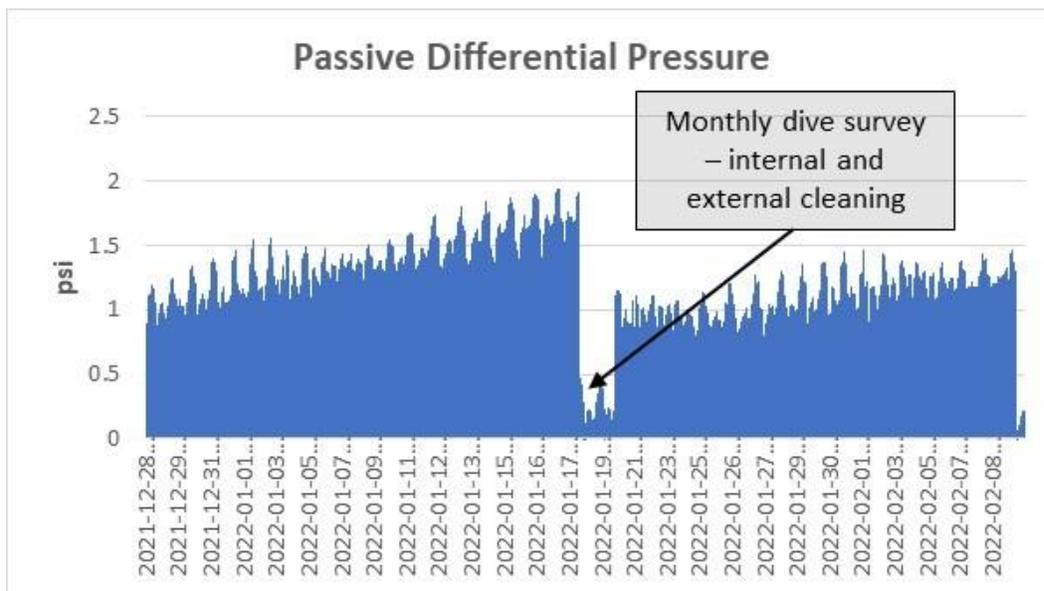
During the final quarter of the study, the passive WWS cleaning frequency remained at eight airbursts per day; the DP fluctuations in Figure 30 correspond to the airburst frequency. DP gradually increased during the period that a functional passive pressure transducer was available (December 27, 2021 through February 9, 2022) (Figure 30). The passive WWS was cleaned in place both internally and externally each month throughout Q4 using a pressure washer and a wire brush. Manual internal and external cleaning by divers was effective for relieving high DP; though, even after the cleaning completed during month 11 (January 2021 dive survey), DP remained at approximately 1 psi.

**Figure 30. Differential pressure through passive wedgewire screening assembly during Q4. Data were limited to the period after the new passive pressure transducer was installed and functioning correctly.**

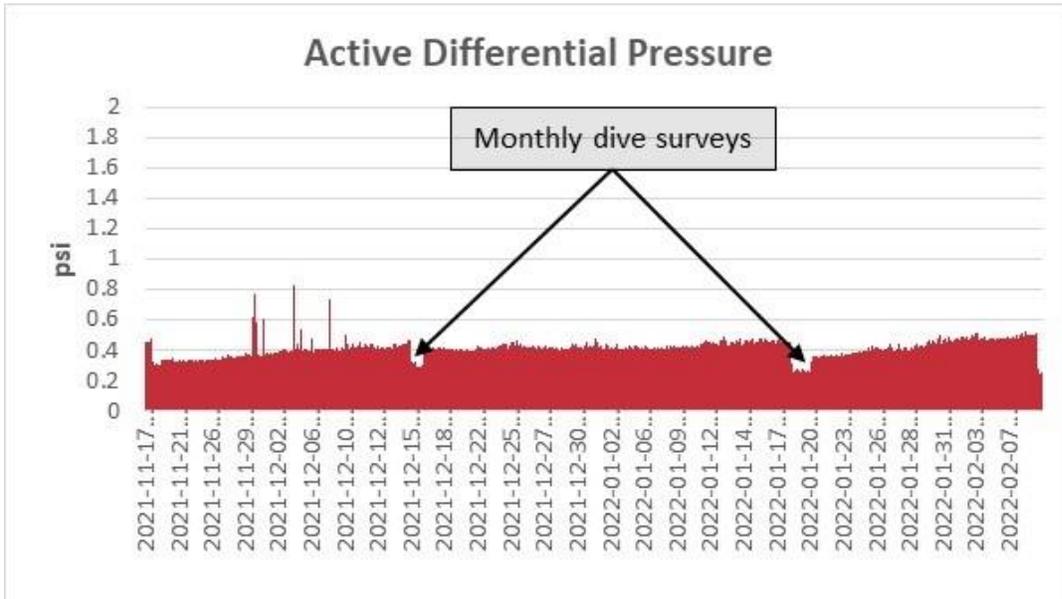
During Q4 of operation, the active WWS functioned reliably and DP remained low through the screening assembly. Cleaning remained on a timed schedule of three times/day (no change from other operational periods in this study). DP remained stable between 0.3 and 0.5 psi (Figure 32).

Figure 32. Differential pressure through active wedgewire screening assembly during Q4.

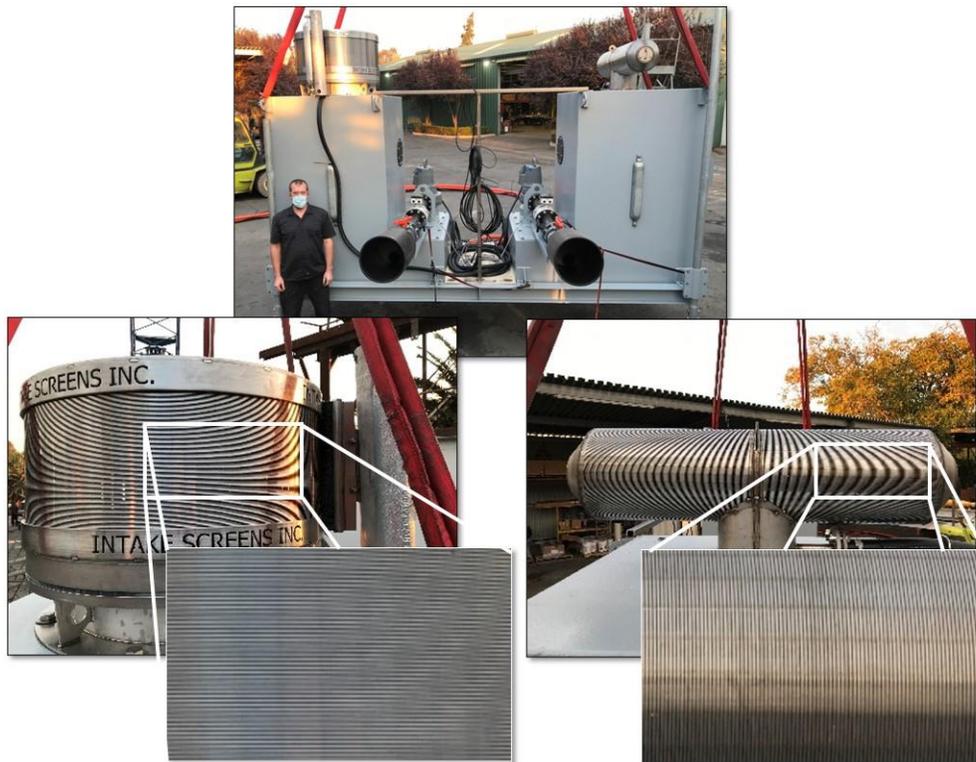
**Figure A-1. WWS Pilot Project skid (top), pilot-scale 1-mm active wedgewire screen from Intake Screens, Inc. (bottom left) and pilot-scale 1-mm passive wedgewire screen from Aqseptence (bottom right).**

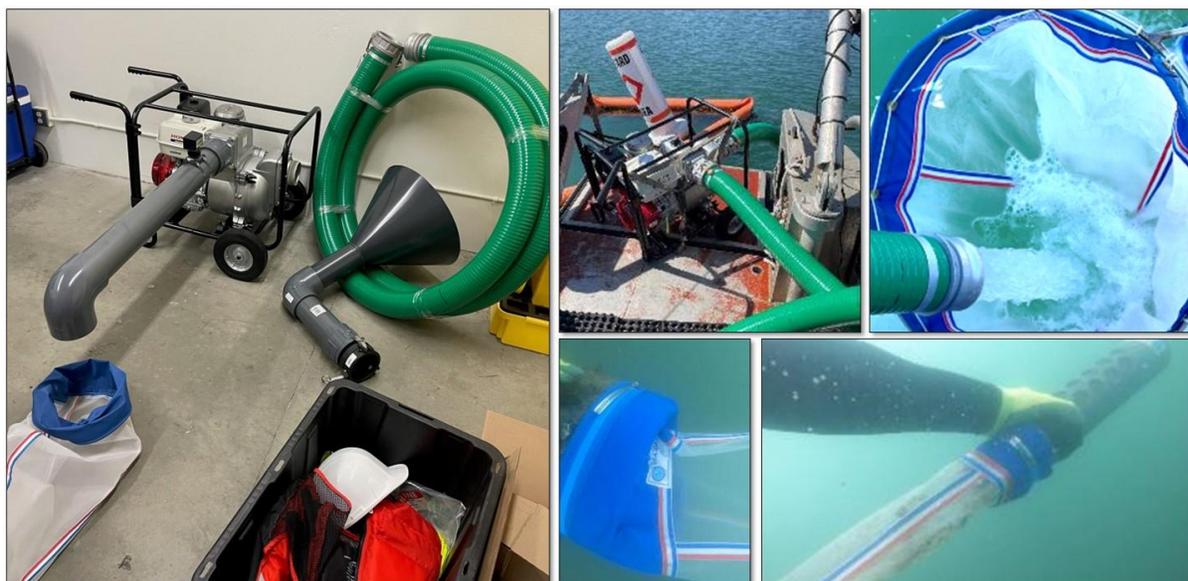
**Figure A-3. Plankton sampling gear. Clockwise from left: ambient sample collection gear (intake cone, flexible hose, trash pump, and plankton net), ambient sample collection gear in field, ambient sample discharge into plankton net, cod end of plankton net attached to discharge from a WWS, mouth of plankton net hose-clamped to discharge from a WWS**

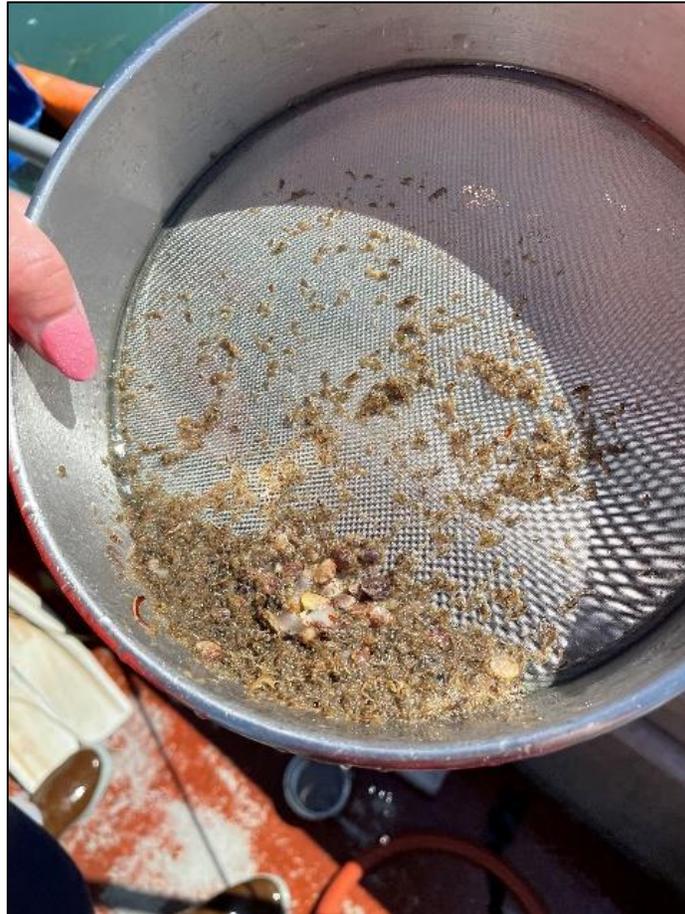
**Figure A-4.** Contents from a sampling event rinsed into a 200- $\mu\text{m}$  mesh screen to condense the sample before transferring to a sample jar for later laboratory analysis.

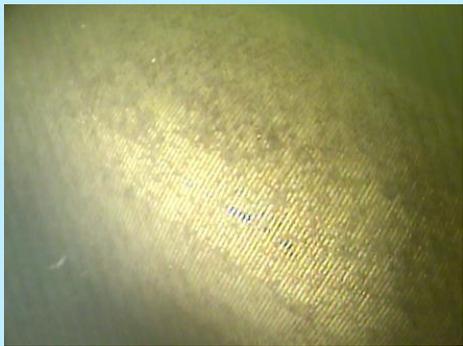
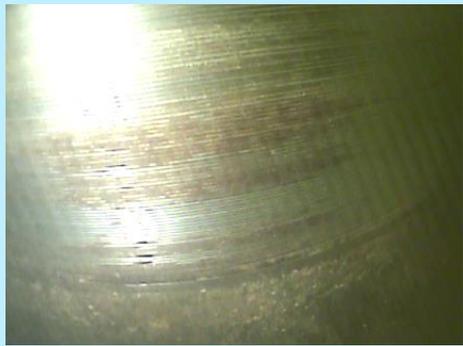
12/15/21	100% coverage, soft growth. Was not quantified. Buildup of growth inside pump box.	Light film, "dusting" (<1/8 in) – appears to include sediment, streaky but mostly clean, brush adjusted.
01/18/22	80-100% soft growth. Didn't indicate thickness. Appears 1/4-1/2 in thick.	Light film, "dusting" (<1/8 in) – appears to include sediment, streaky but mostly clean.
02/09/22	80-100% soft growth. Didn't indicate thickness. Appears 1/4-1/2 in thick.	10-20% soft algae growth. Sporadic across screen. Diver noted brush may need to be adjusted again.
<p><sup>1</sup> This dive survey followed the third month of operation during which the screens were programmed to initiate cleaning cycles based on low flow rate or high DP. During this period, the passive WWS did not airburst for approximately 2.5 weeks and the active WWS did not rotate at all.</p>

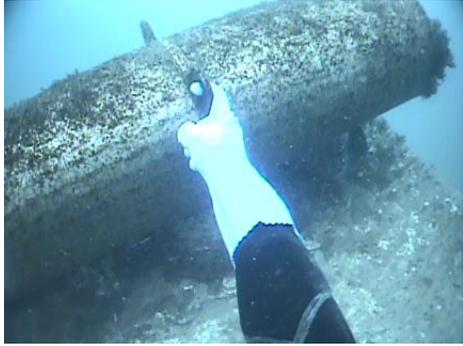
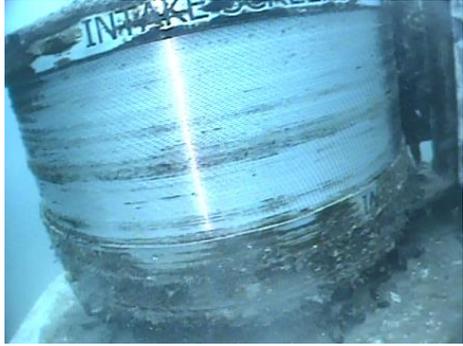
Dive Survey Date	Passive WWS	Active WWS
01/18/22

<p><sup>1</sup> This dive survey followed the third month of operation during which the screens were programmed to initiate cleaning cycles based on low flow rate or high DP. During this period, the passive WWS did not airburst for approximately 2.5 weeks and the active WWS did not rotate at all.</p>
